**O & M INSPECTION REPORT
FOR NAVIGATION AND SHORE PROTECTION PROJECTS**

1. Project Name: Hilo Deep Draft Harbor

2. Date of Inspection: May 3, 2004

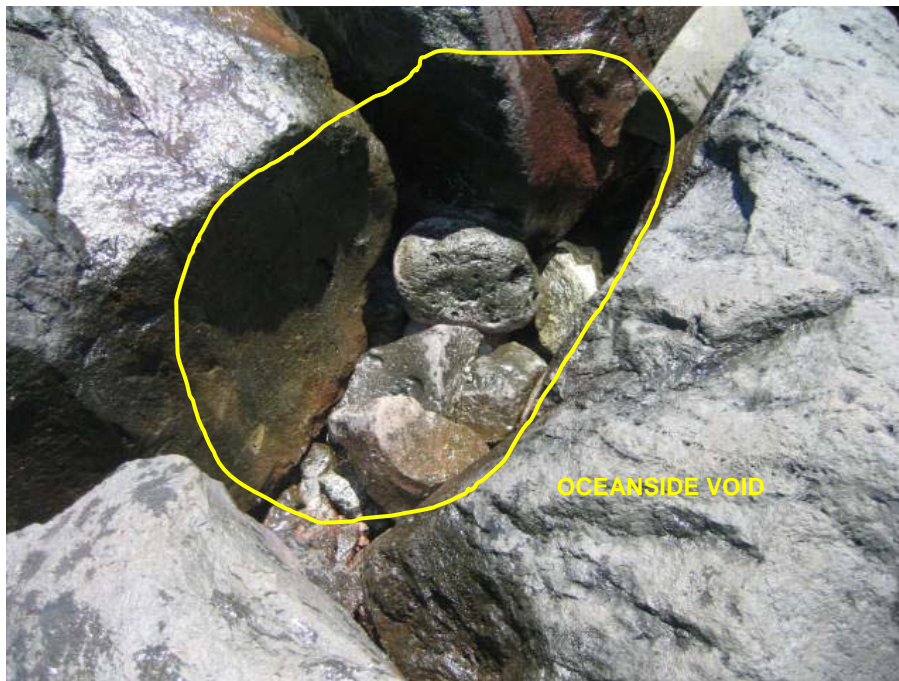
P58. Sta. 57+35, 4ft x 4ft x 2ft void on oceanside

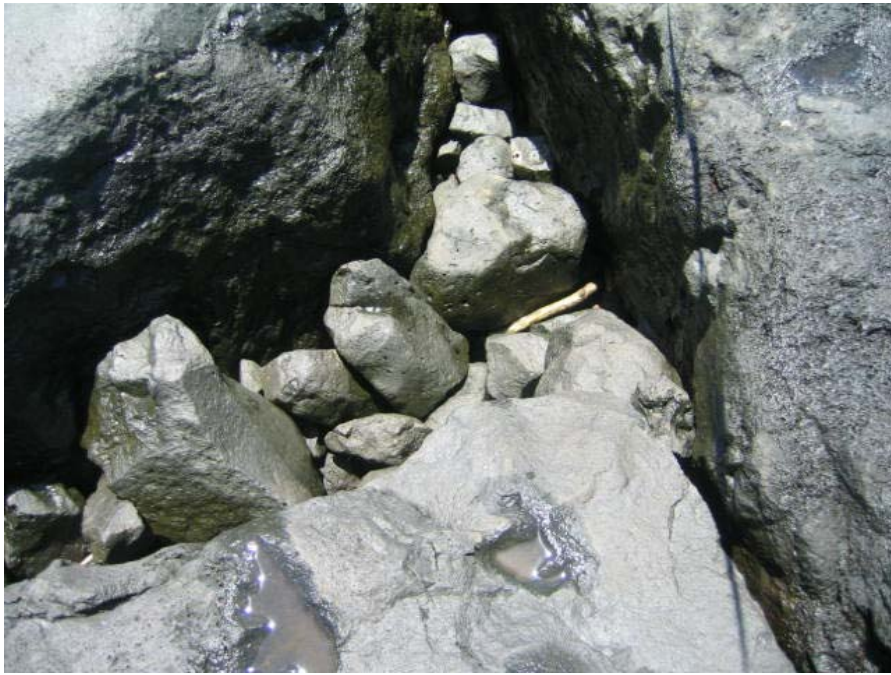
P59. Sta. 57+58, 2ft separation on armor stone at centerline

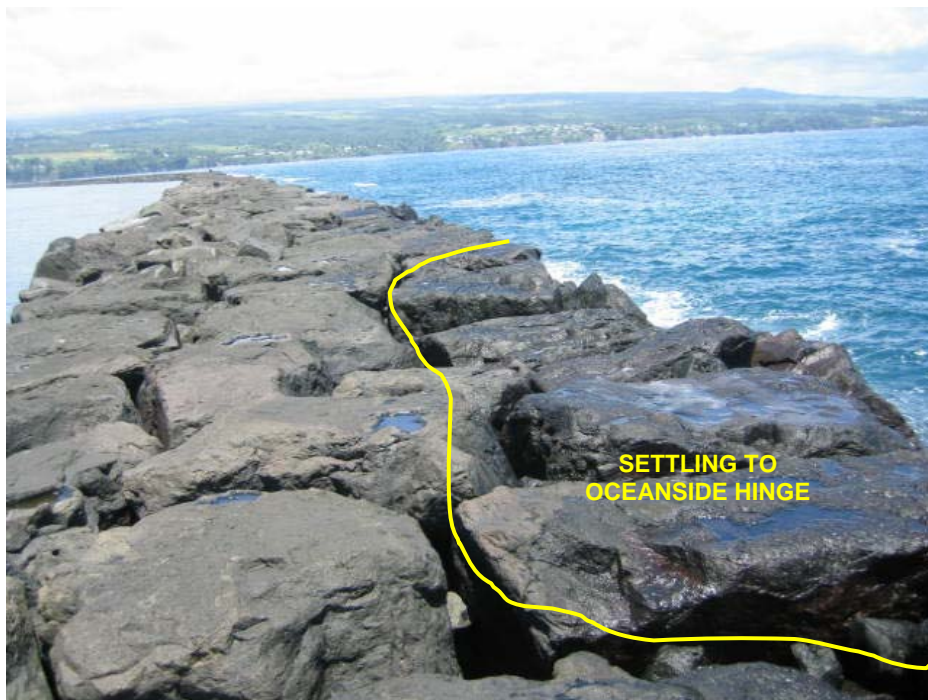
P60. Sta 59+82, OS, Settling to oceanside hinge

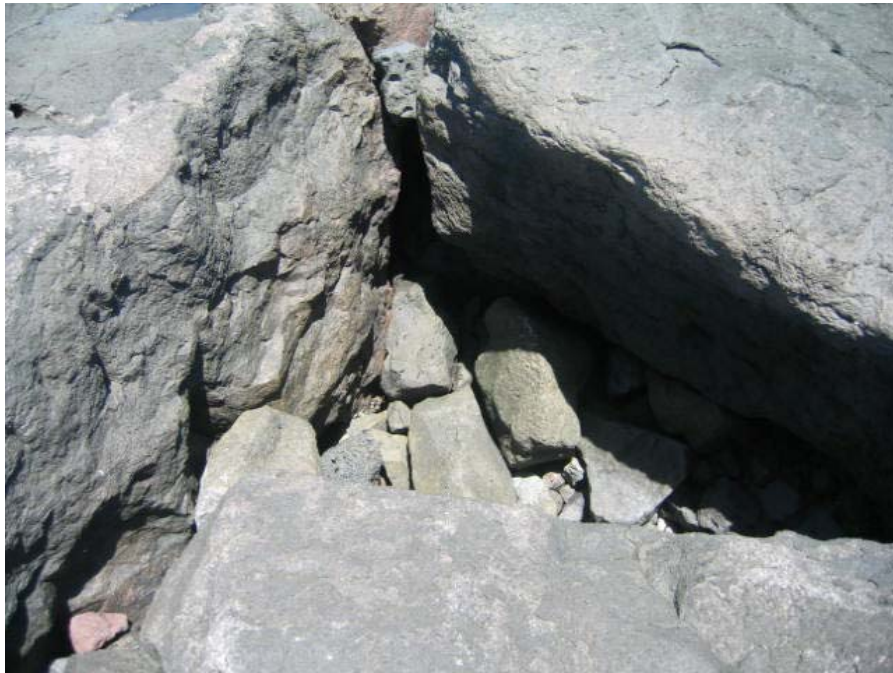
P61. Sta 60+80, Void at harborside of crest

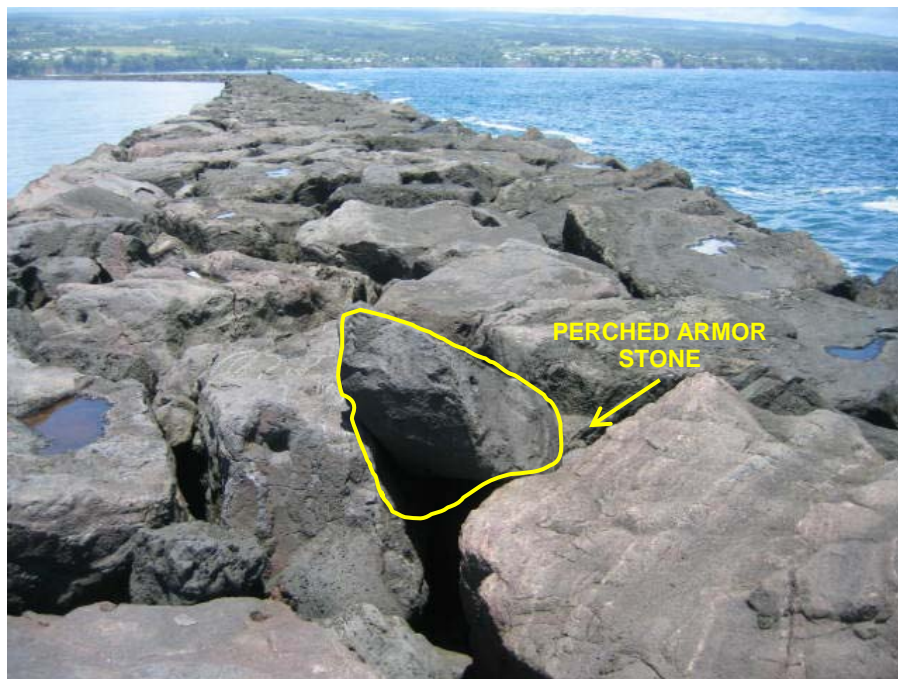
P62. Sta 62+00, 1' x 3' perched stone on crest

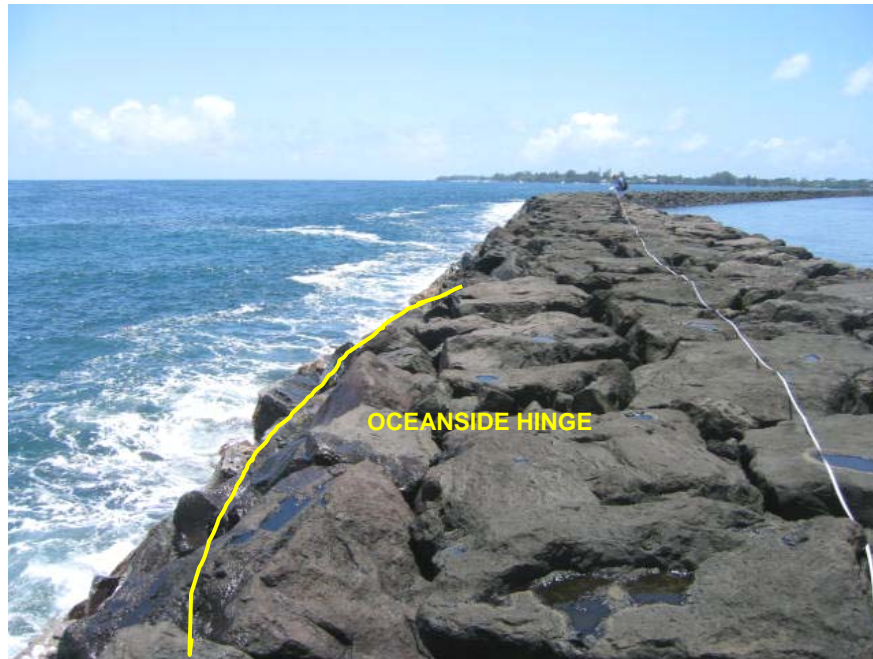
P63. Sta 62+30 to 63+50, Oceanside hinge bows out

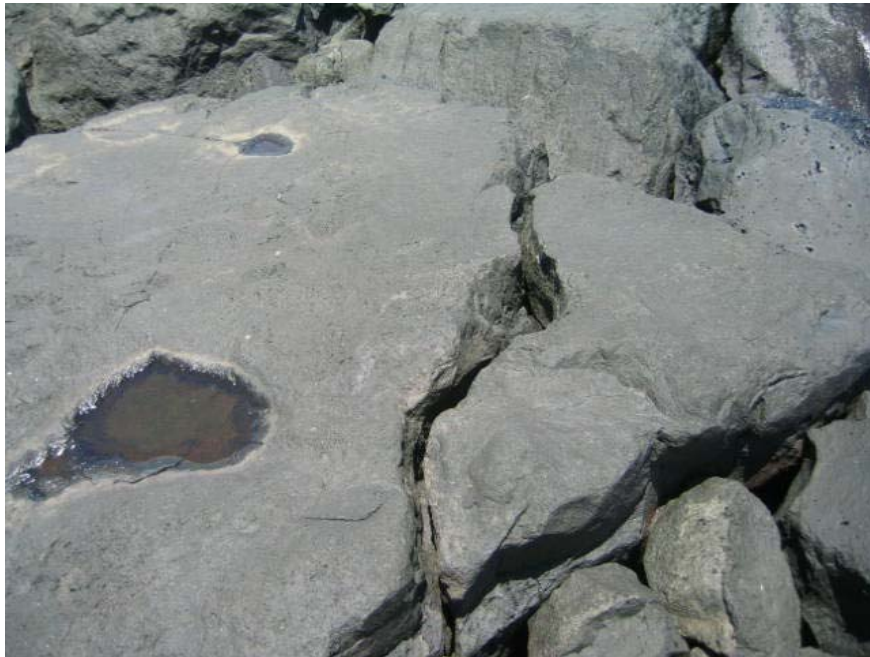
P65. Cracked armor stone on crest

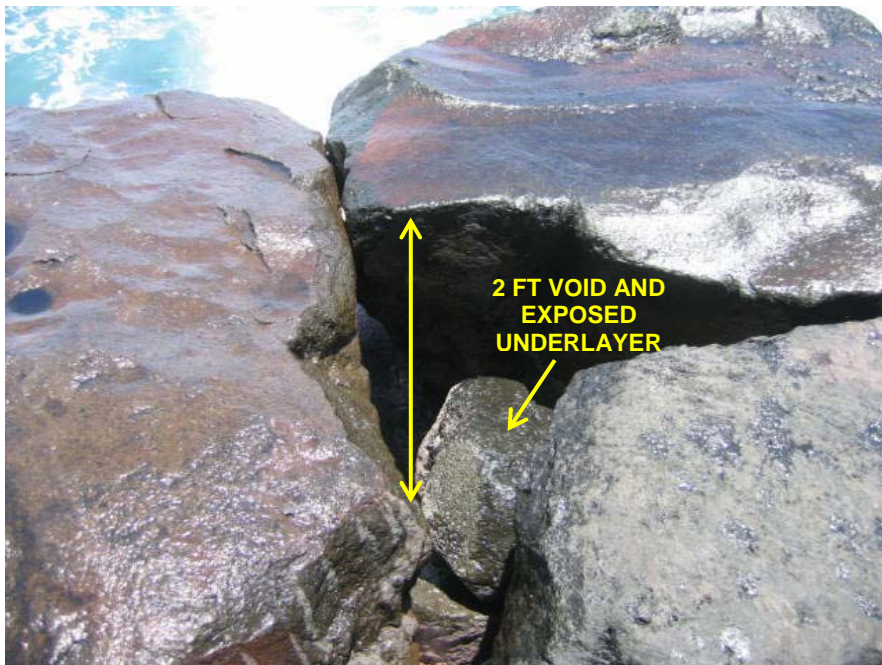
P66. Sta 66+35, 2 ft void on crest and exposed underlayer

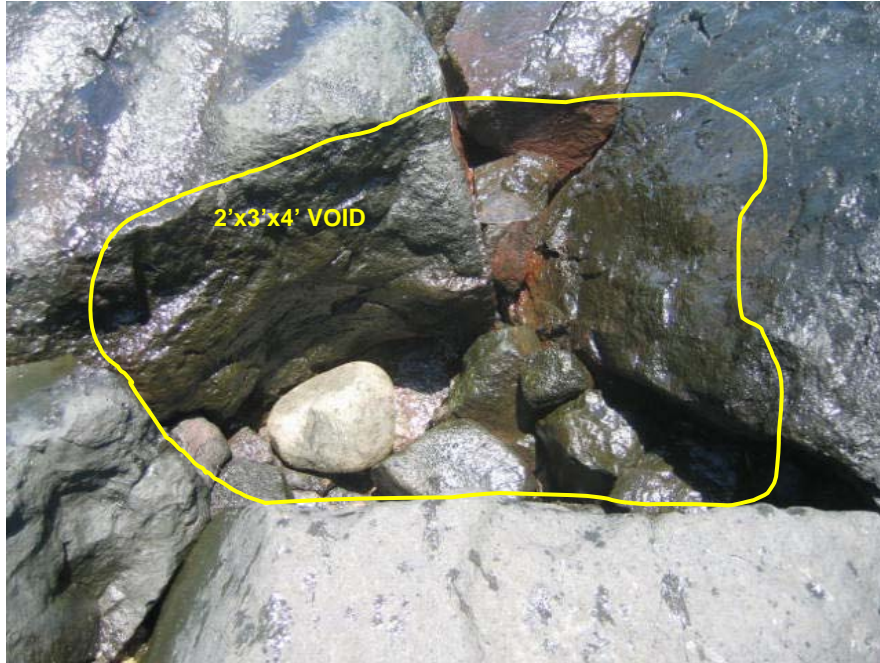
P67. Sta 67+19, OS, 2'Wx3'Lx4'D void at oceanside hinge

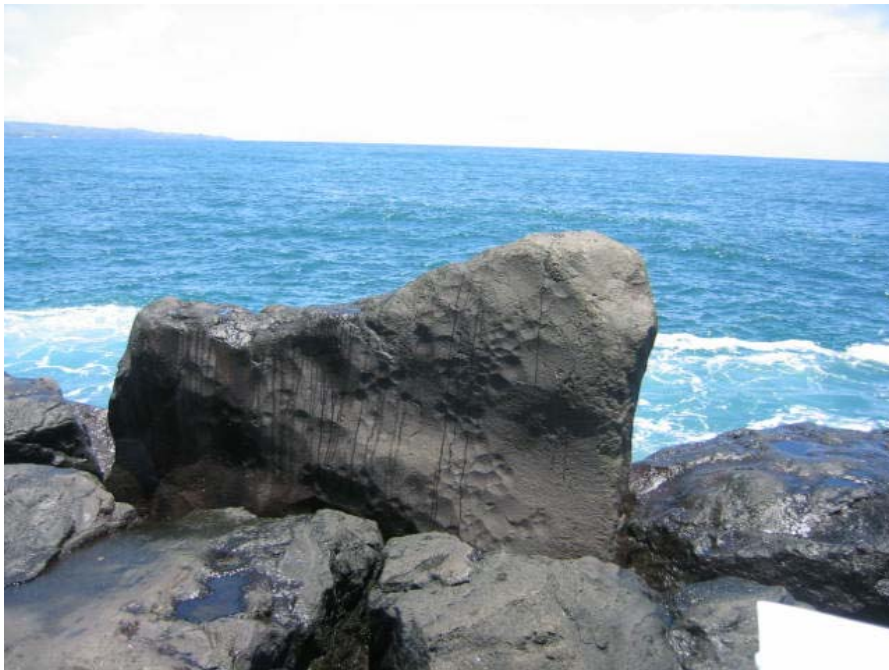
P68. Sta. 68+78, Perched armor stone resting on oceanside crest, "Tombstone".

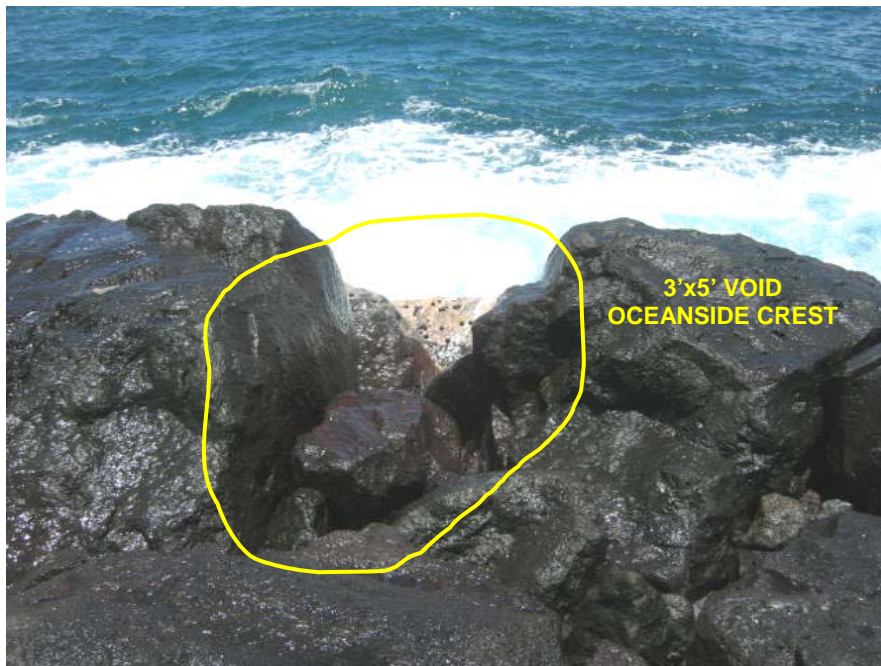
P70. Sta 71+10, OS, 3ft x 5 ft void on oceanside of crest

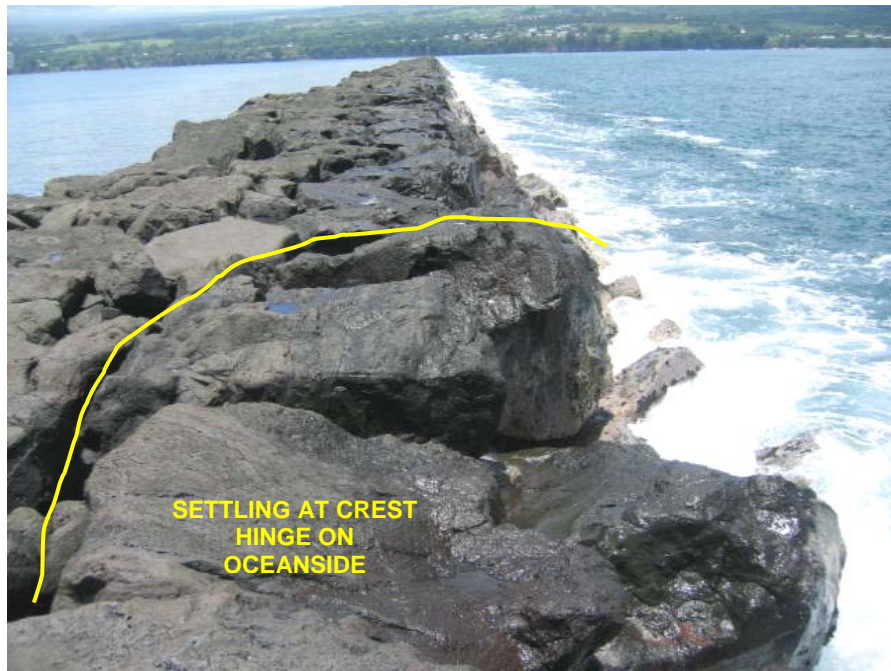
P71. Sta. 72+00, OS, Monitor settling at hinge.

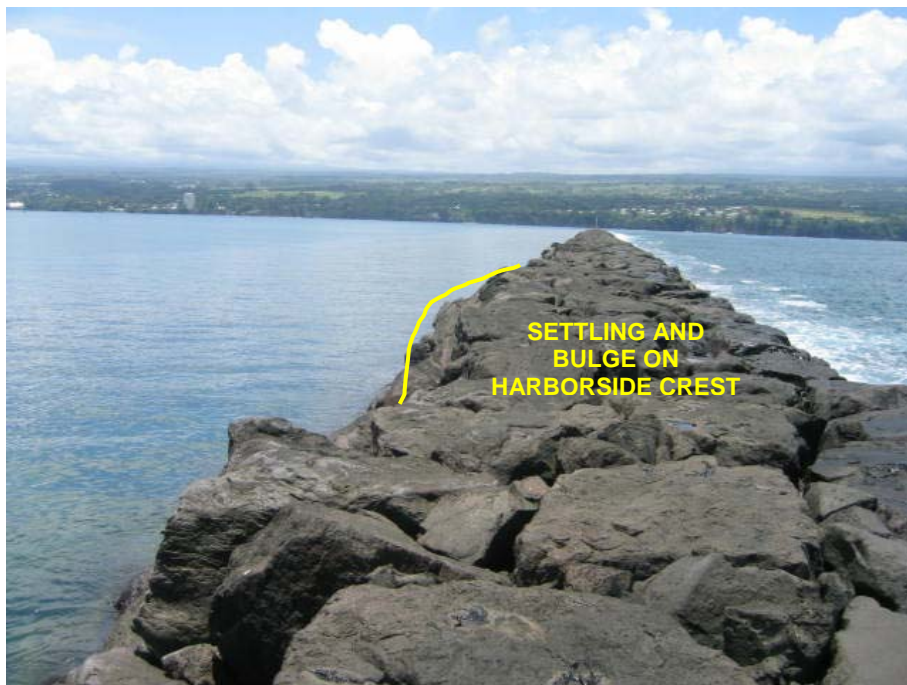
P72. Sta 73+00 to 73+64, HS, Slight settling at crest and HS bulge

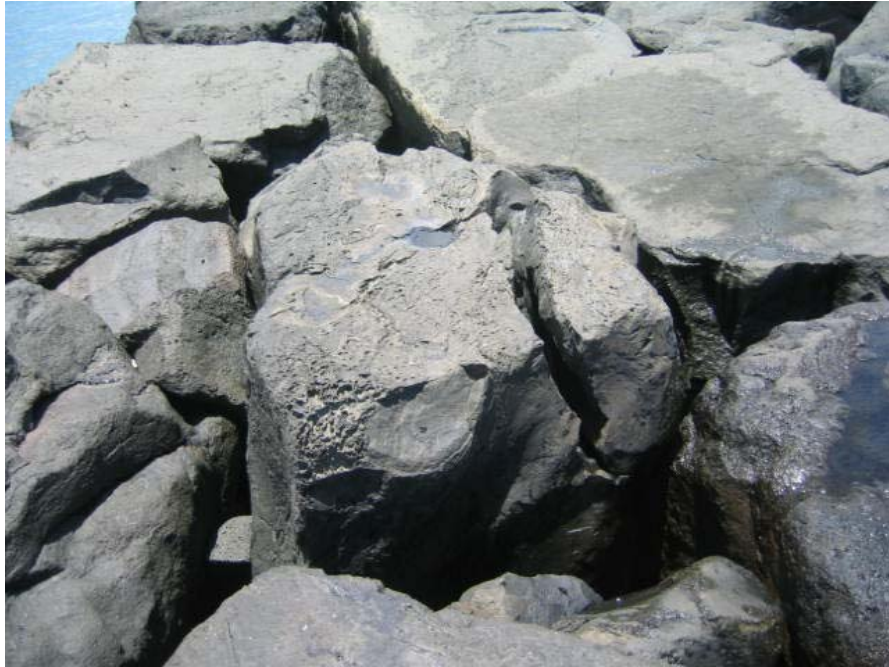
P73. Sta. 74+40, Crest, one of 3 fractured armor stones in this area.

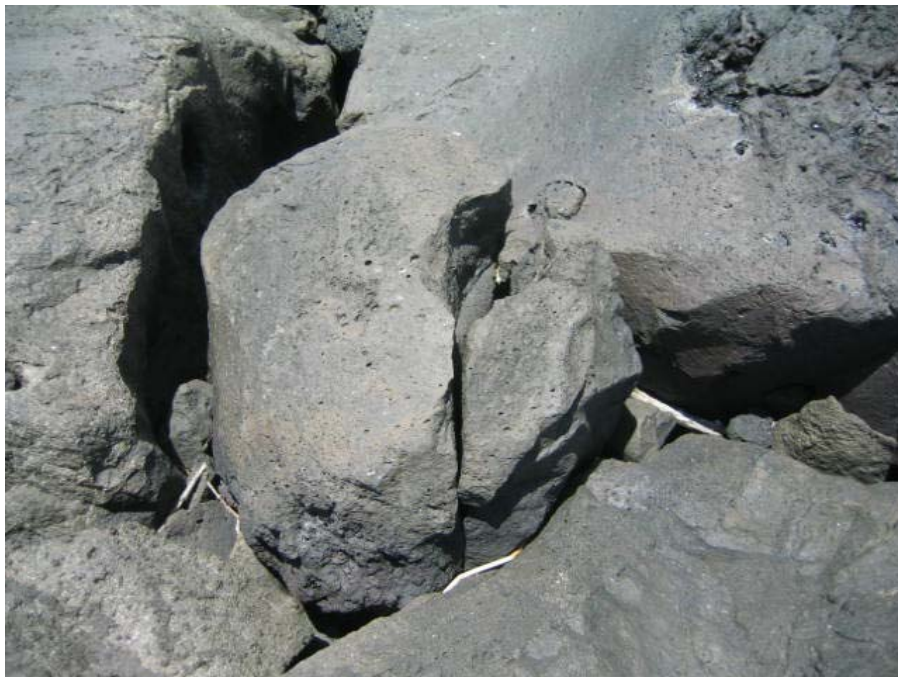
P74. Sta. 75+85, Crest, 1 small armor stone fractured 3x.

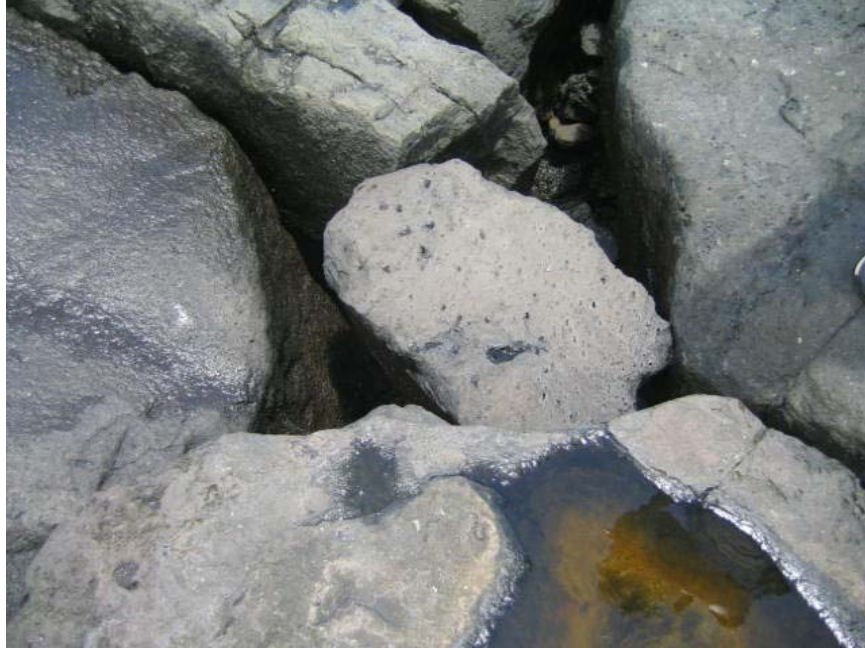
P75. Sta. 78+80, OS, Bridging at hinge

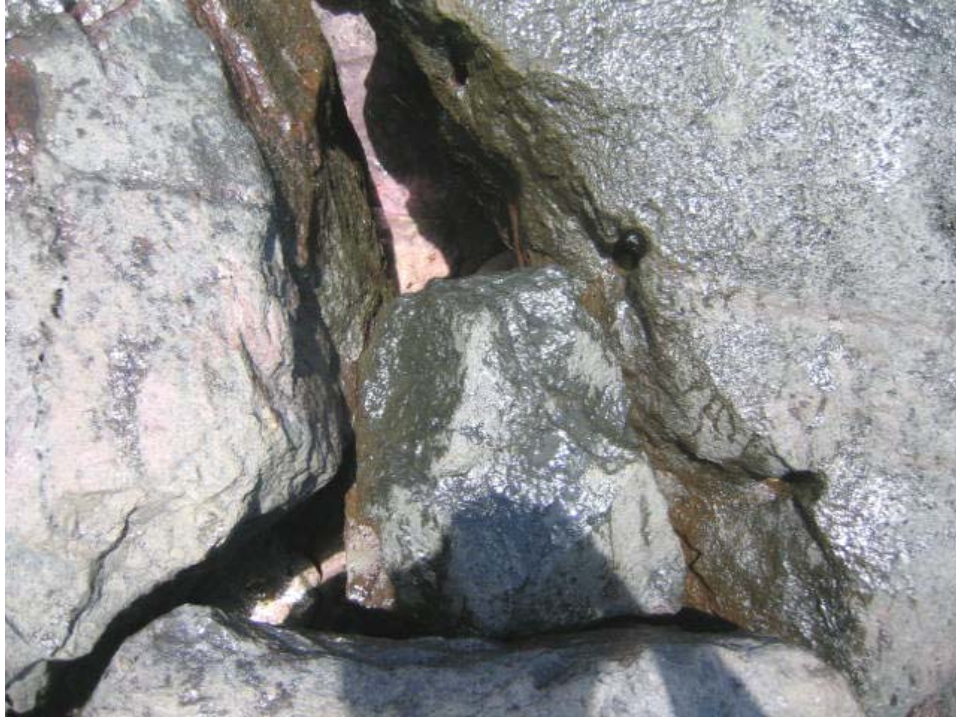
P77. Sta. 78+80, OS, Bridging at hinge

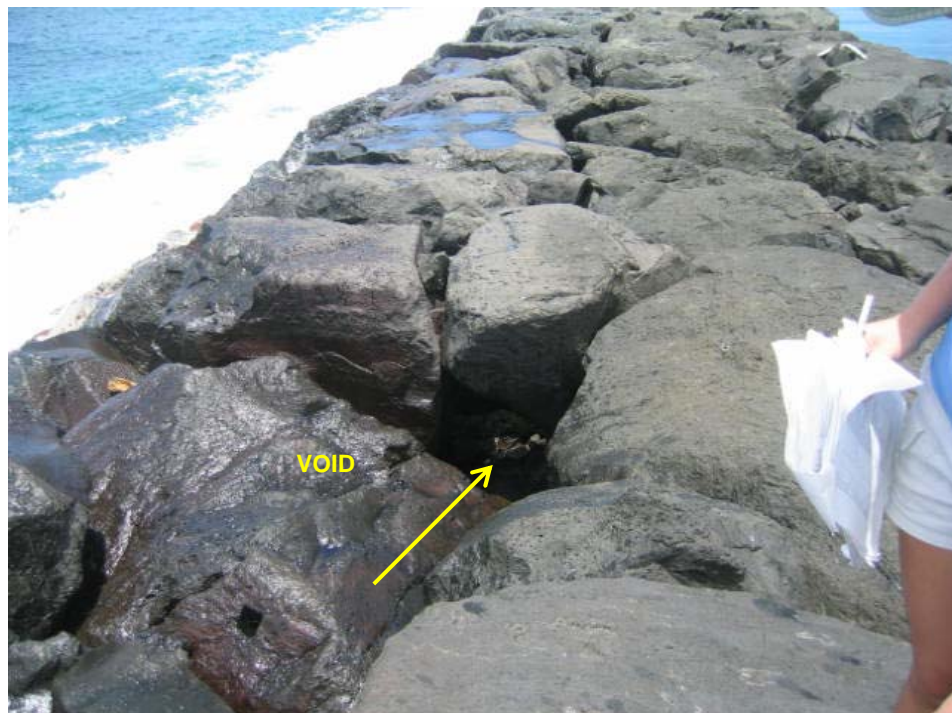
P78. Sta. 81+34, OS, Void at crest.

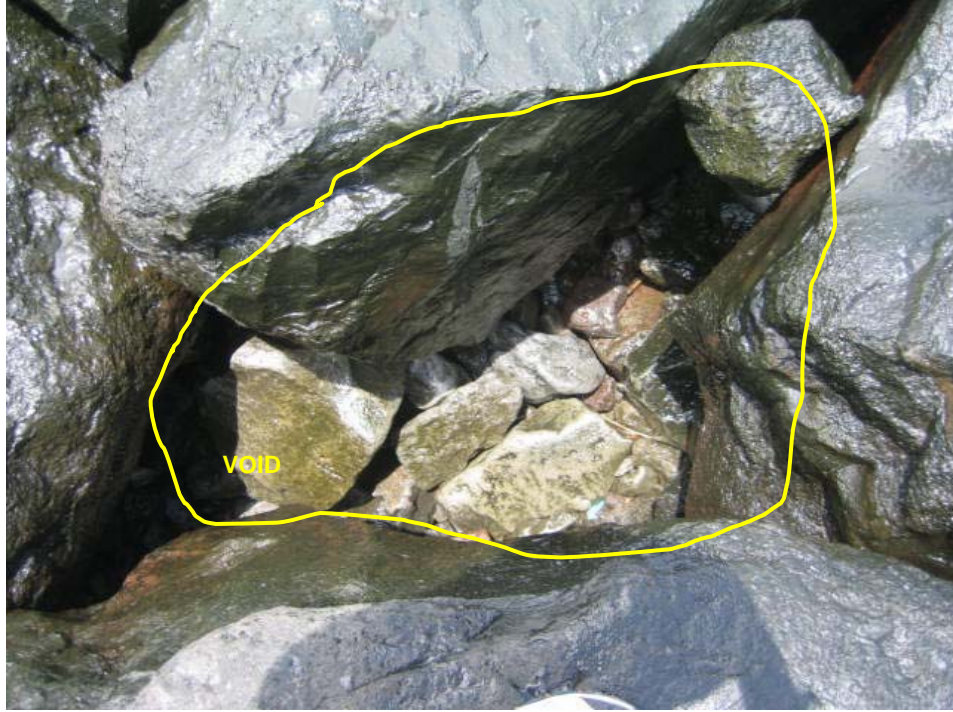
P79. Sta. 81+47, Void at centerline exposing underlayer.

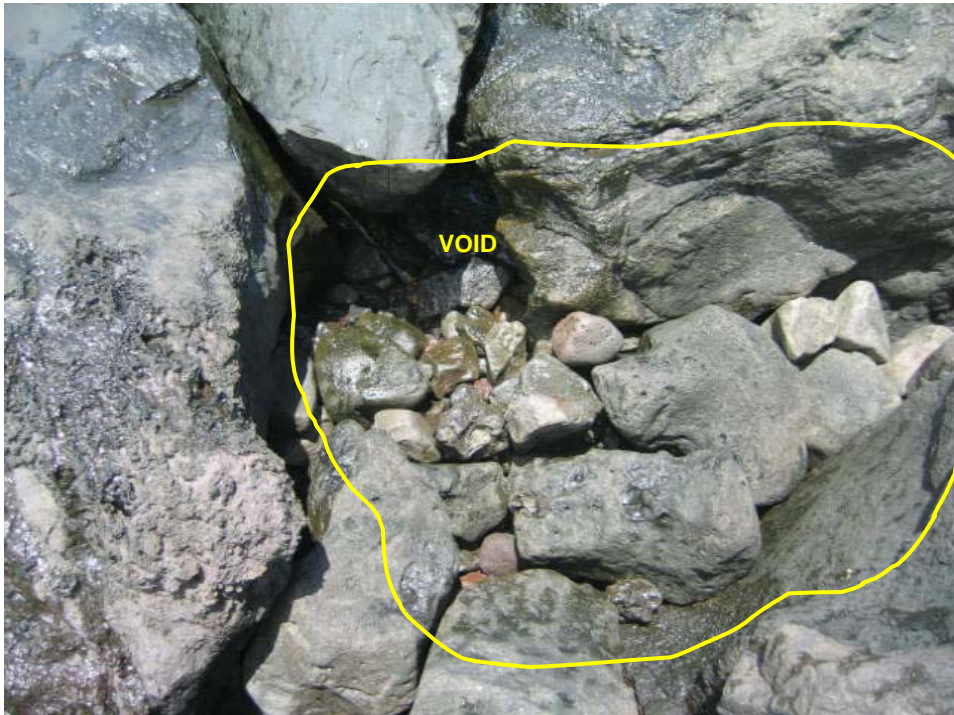
P80. Sta. 81+61, HS, Void exposing underlayer.

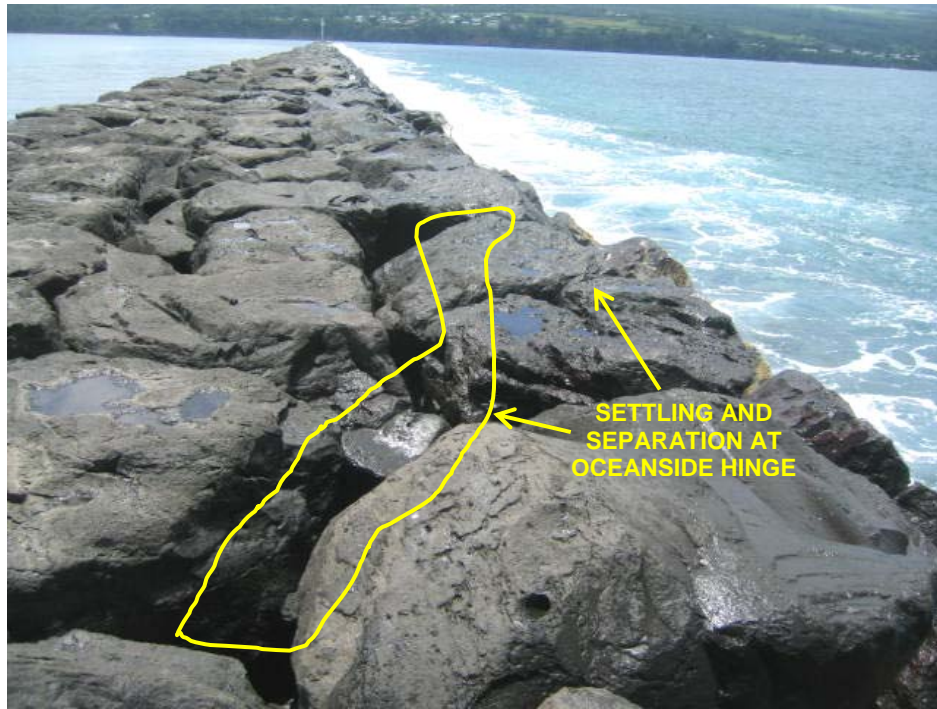
P81. Sta. 90+00, OS, Settling at hinge with separation.

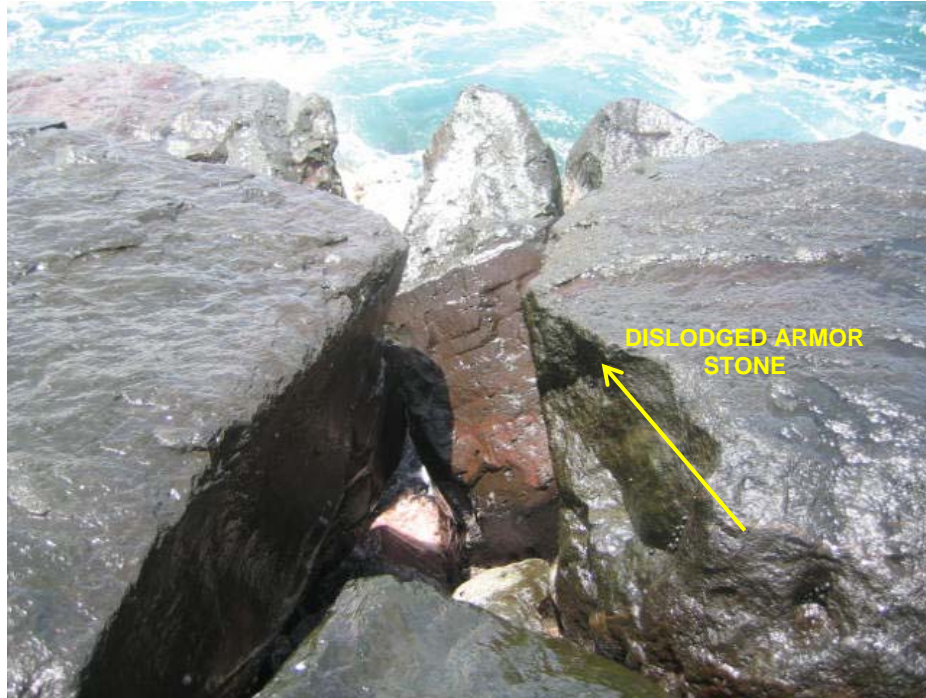
P83. Sta. 93+77, OS, Dislodged armor stone at hinge.

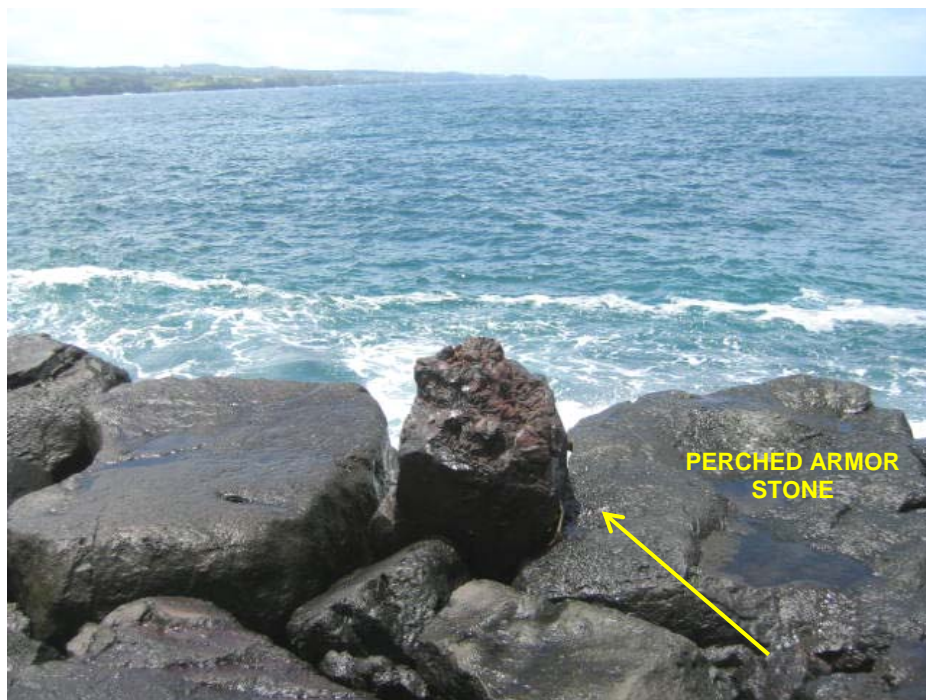
P84. Sta. 95+78, OS, Perched stone on crest.
